# MISSION:

ISSUE 9

# MYSTERY at the BOTTOM of the BALTIC SEA

## Searching for answers to explain the 1994 sinking of the MS *Estonia*

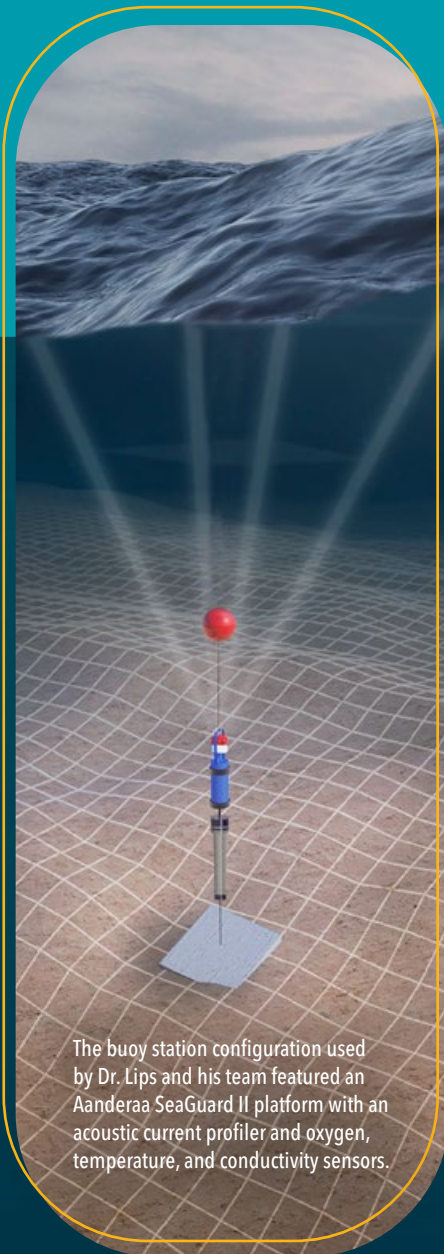
The buoy station configuration used by Dr. Lips and his team featured an Aanderaa SeaGuard II platform with an acoustic current profiler and oxygen, temperature, and conductivity sensors.

Dr. Urmas Lips of Tallinn University of Technology in Estonia is part of the research team. He uses an [Aanderaa current profiler](#), an instrument that sends out acoustic signals into the water to measure the speed of currents, to help him collect data that describes how water moves around the ship.

The instrument is deployed to 3 to 4 meters from the seabed and measures nearly all the way up to the surface. It also has sensors that measure oxygen content, salinity, and temperature.
